# NATIONAL TRANSPORTATION SAFETY BOARD

## RAILROAD ACCIDENT REPORT

FIRE ONBOARD AMTRAK PASSENGER TRAIN  
TRAIN NO. 11, COAST STARLIGHT  
GIBSON, CALIFORNIA  
JUNE 23, 1982

NTSB / RAR-83 / 03

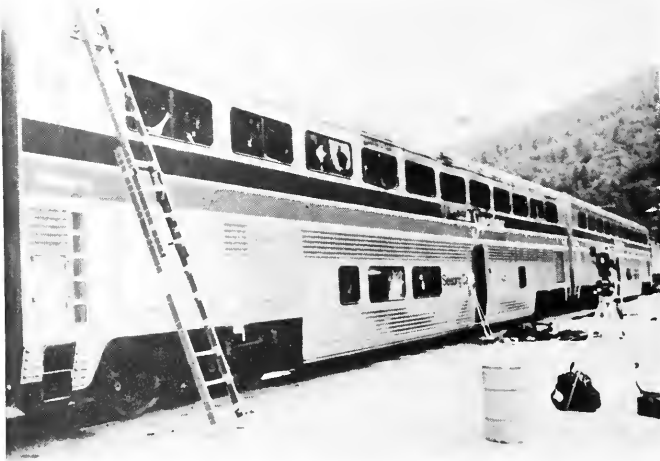
The upper level of sleeper car No. 32010 (1130) was destroyed; the lower level was damaged by the intense heat and smoke. (See figures 6, 7, and 8.)

Figure 6.--Exterior view of the 1130 car.

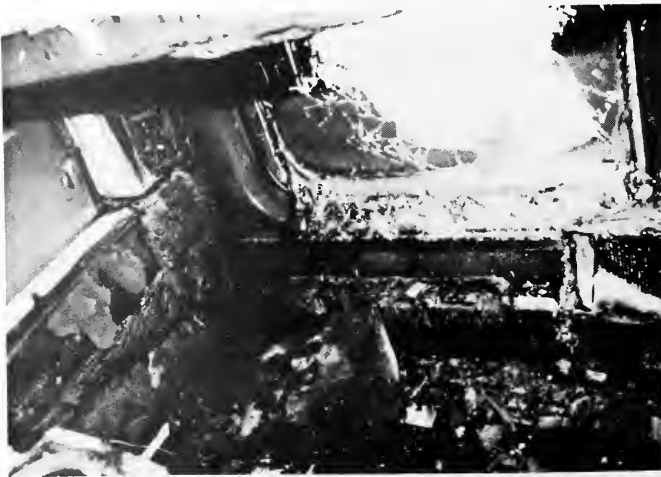
Figure 7.--Interior view of burned economy-type bedroom in the 1130 car.

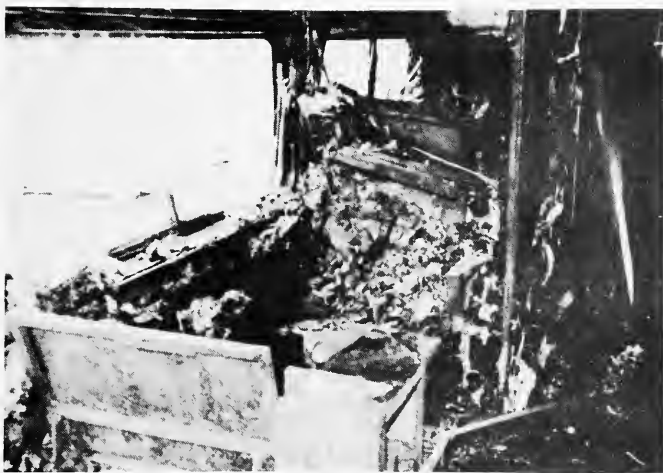
Figure 8.--Interior view of burned economy-type bedroom in car 1130.
